State of California - The Resources Agency  
DEPARTMENT OF PARKS AND RECREATION  
**PRIMARY RECORD**

Page 1 of 2 \*Resource Name or #: Ace Gallery (WSE 15)

\*P11. Report Citation: Parsons Brinckerhoff. 2011. Westside Subway Extension Historic Properties Supplemental Survey Report

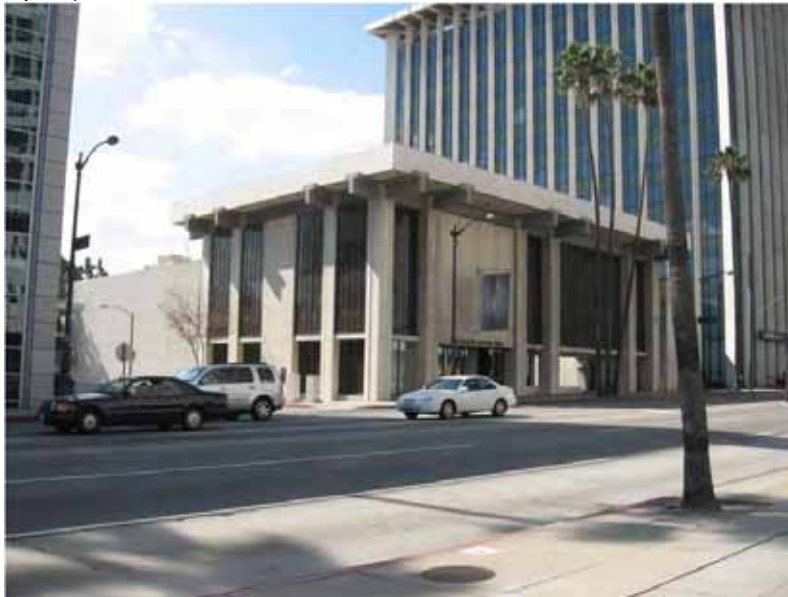
P5a. Photograph or Drawing (Photograph required for buildings, structures, and objects.)

The Ace Gallery is located at 9430 Wilshire Boulevard in a heavily developed urban commercial setting. The core building of the current Ace Gallery building was a commercial restaurant building constructed in the 1930s, which was rehabilitated in 1948/1949 to create a larger building designed in the Brutalism style of architecture. The building occupies the majority of the lot and has a north-facing orientation. The main mass is rectangular and is situated at the front of the lot. It is three stories. The balance of the building is only two stories and extends towards the rear (south). It is the front massing that has been designed to portray a Brutalist style of architecture. The front massing has a wide flat roof supported by T-shaped rafters and a wide eave overhang. The body of the front massing has an articulated concrete frame formed by large concrete pillars that extend the height of the three stories. On the upper two floors, glass curtain walls fill in-between the concrete pillars, emphasizing the vertical dimension of the building. On the front (north) elevation, a recessed pedestrian entrance is located to the east of a pass-through driveway under the upper floors to the parking lot courtyard. The rest of the building that extends to the south is designed in a

strictly utilitarian manner, with metal hopper windows used sparingly, and walls made of concrete or brick. Since being rehabilitated in 1948/49 in a Brutalist style, the building appears to have not been altered and is in excellent condition.

\*P5b. Description of Photo: (view, date, accession #)

View to the southwest, April 2011
